## **BMH Mechanical**

INVOICE INVO407

DESCRIPTION	RATE	QTY	AMOUNT
HVAC Inspection	\$808.71	1	\$808.71

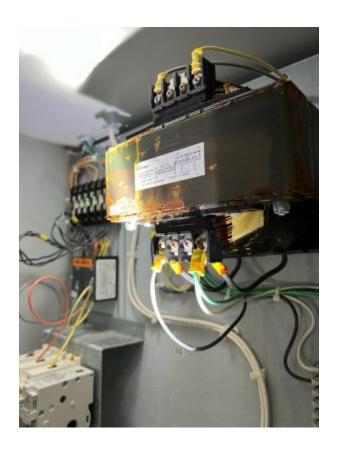
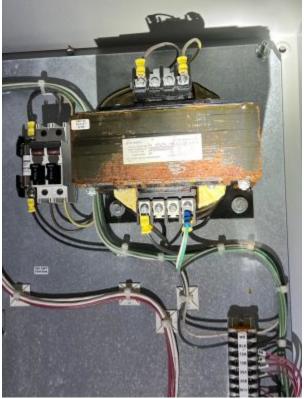
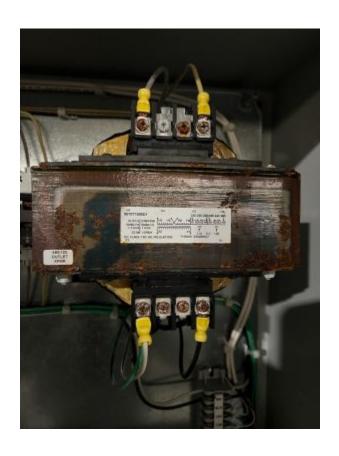
Returned to Glancy's warehouse for a final inspection. The units were moved and allowed me to gain full access to all areas of the units that were inaccessible before. I found that the units were cleaned thoroughly and most of the spot rust had been removed/treated with galvanized paint. Now that the units were completely accessible, I was able to access both blowers and electrical sections on all units. I have some concerns with the integrity of the fan motors. It appears that more than 1/2 of the motors bearings are audibly loud and stiff. This is most likely the cause of condensation forming in the motors sealed bearings and rusting. Also, there are some transformers that have an excessive amount of rust. I took some videos of them compared to one of the new units. My suggestion is replacement of both fan motors in the 11 units and at least 1/2 of the transformers on the units that were stored outside. My concern is that all the motors are compromised on the 11 outdoor units. Attached is some pictures of transformers and I will forward videos of motors turning.
